## **GRENFELL TOWER INQUIRY: PHASE 2 REPORT**

REPORT of the PUBLIC INQUIRY into the  
FIRE at GRENFELL TOWER  
on 14 JUNE 2017

Volume 4  
Part 6 – The refurbishment of Grenfell Tower

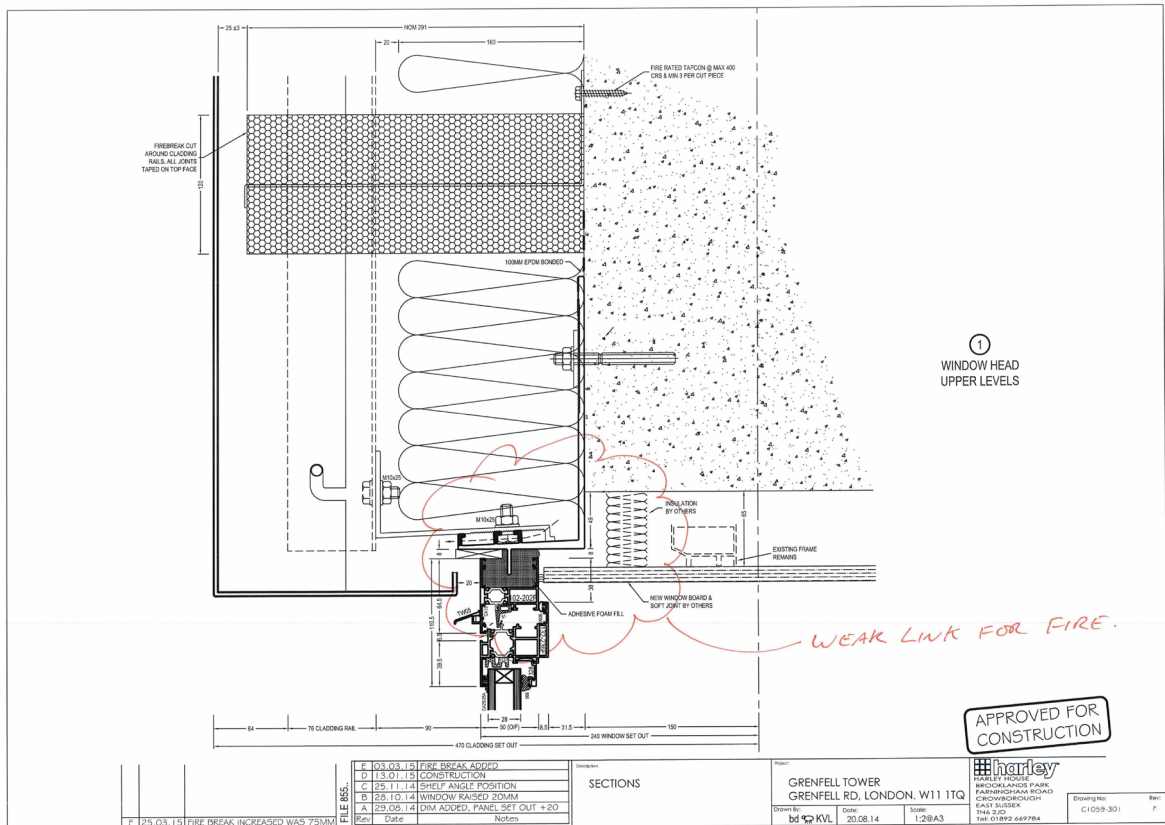
**Figure 57.1 – Harley drawing 301**

- 57.54** The second sketch which Mr Mort had prepared was based on a drawing produced by Harley, to which he had added a bubble containing the note "weak link for fire".<sup>2013</sup> The sketch showed the new window set back from the edge of the building, exposing a gap between the window brackets, as shown below.<sup>2014</sup>

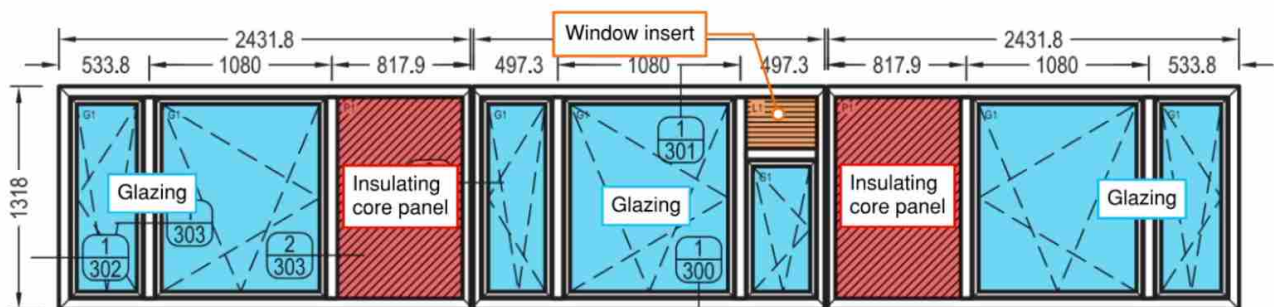
**Figure 58.1 – Typical elevation for three-window configuration**

- 58.3** After the fire it was found that both panels contained a core of Styrofoam, held between two sheets of aluminium.<sup>2153</sup> Styrofoam is a form of extruded polystyrene (often referred to as “XPS”) and is combustible.<sup>2154</sup> Although in his Phase 2 experimental work Professor Bisby found that those panels made the lowest contribution to the energy available in the external wall (only about 2–3% of the total energy available per floor),<sup>2155</sup> he also found that they were relatively easy to ignite and, once ignited, had a comparatively high energy heat release rate per unit area.<sup>2156</sup> He concluded that although they were not a primary cause of, or contributor to, the spread of fire across the external walls, they may have played an important part in the early development of the fire in and immediately outside Flat 16.<sup>2157</sup> Accordingly, in this chapter we seek to explain how that combustible material came to be incorporated into the external wall of Grenfell Tower.

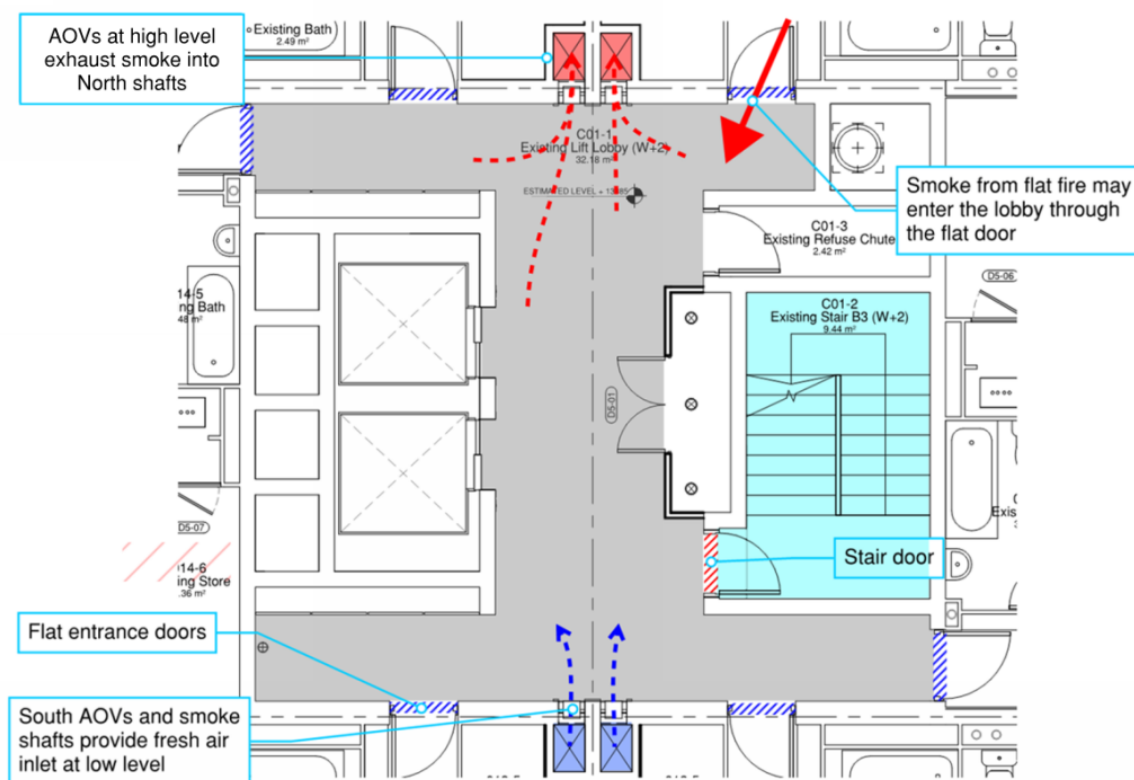
Figure 60.1 – Operation of the original smoke ventilation system on the fire floor

- 60.6 Accordingly, the system operated by ventilating the lobby area with the intention of protecting the escape route through the lobby.
- 60.7 The system did not follow the recommendations of British Standard Code of Practice CP3 1971 (the standard which appears to have been used when designing the building),<sup>2340</sup> section 3.4.3.1(4) of which required that for buildings with a single stairway, cross ventilation in common access areas should be provided by an opening with a free area of at least 1.5m<sup>2</sup>.<sup>2341</sup> The available aggregate free area of 0.48m<sup>2</sup> at Grenfell Tower was significantly less than that.

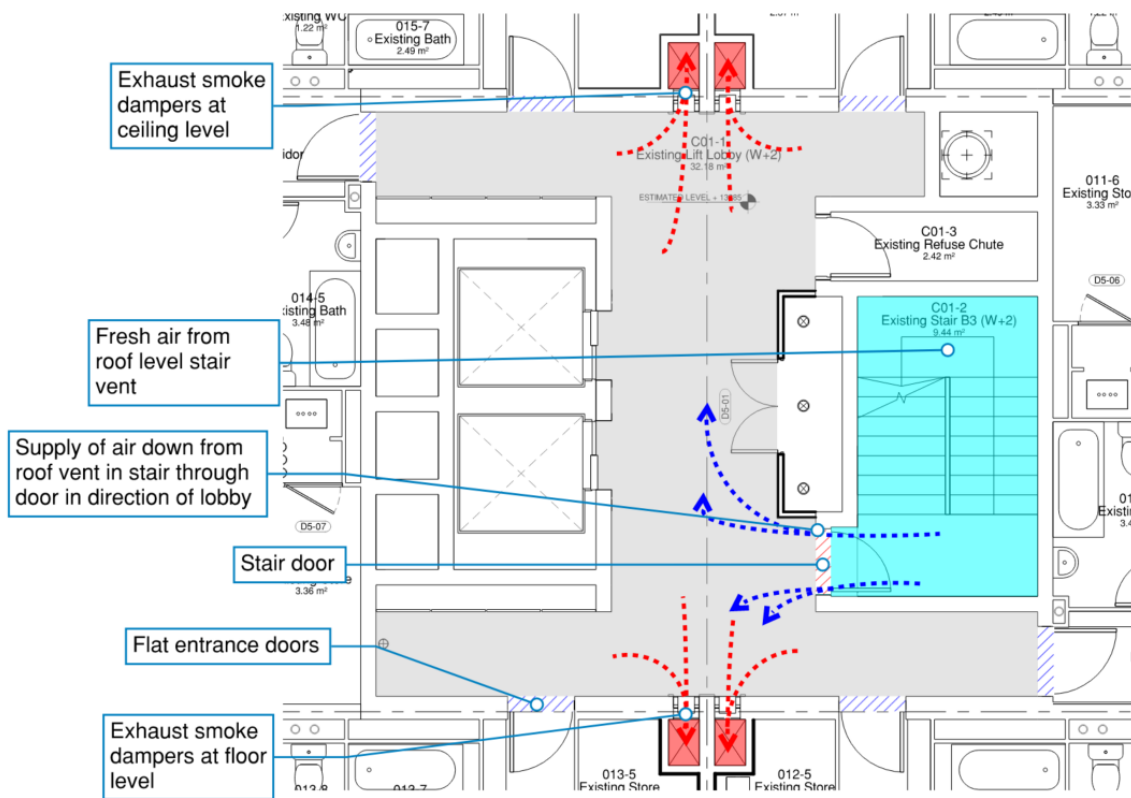
**Figure 60.2 - Design intent of the smoke extract system in Grenfell Tower for Level 2 to Level 23**

**60.33** Below is an illustration of the way in which the new smoke ventilation system was intended to operate. The blue lines indicate fresh air from the roof vent at the top of the stairs entering the lobby through the door to the stairs; the red lines indicate the movement of smoke and hot gases out of the shafts on the north and south sides of the lobby.<sup>2393</sup>

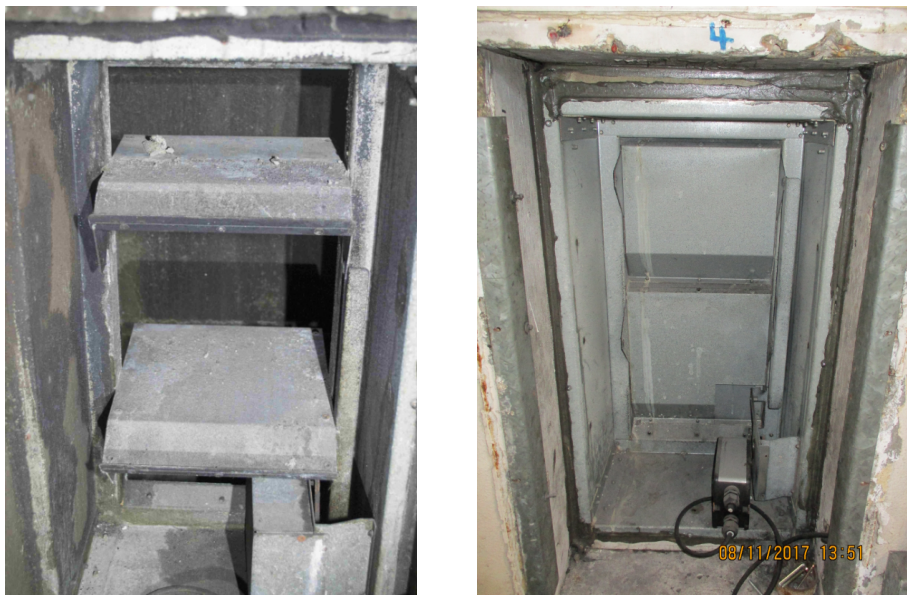
**Figure 60.3 – Examples of dampers in an open and closed position**

**60.49** The Gilberts Series 54 damper is shown in the open and closed positions in the following photographs taken after the fire.<sup>2407</sup>

**60.50** It is opened and closed by an actuator (a small electric motor)<sup>2408</sup> that moves the blades. When smoke is being drawn up the shaft the damper prevents it from entering the lobbies. It therefore plays a vital role in protecting the atmosphere in the lobbies not directly affected by the fire.
