## **GRENFELL TOWER INQUIRY: PHASE 2 REPORT**

REPORT of the PUBLIC INQUIRY into the  
FIRE at GRENFELL TOWER  
on 14 JUNE 2017

Volume 4

Part 6 – The refurbishment of Grenfell Tower

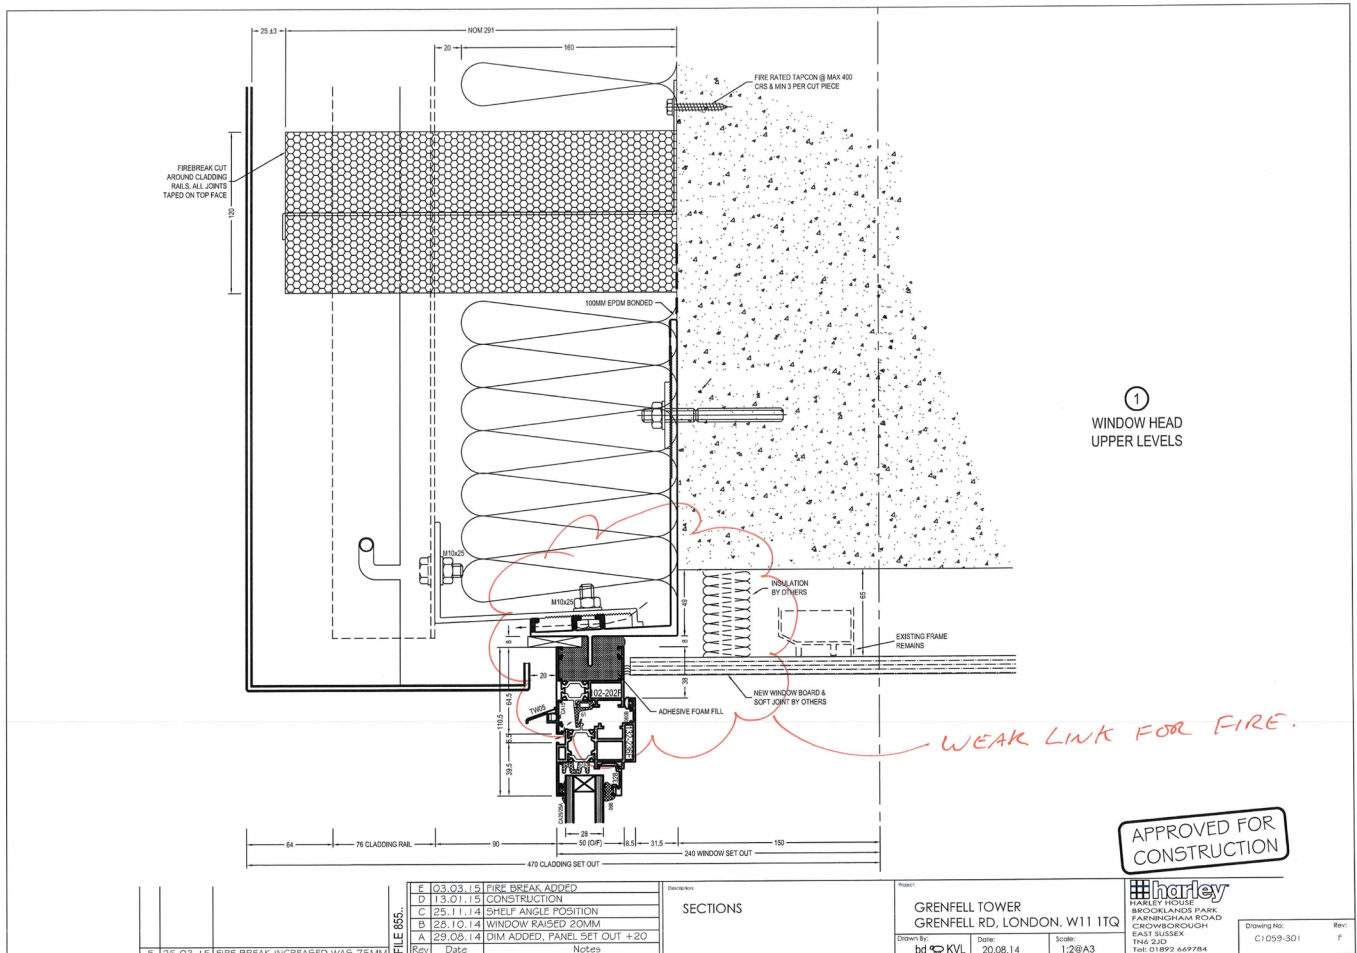
Figure 57.1 – Harley drawing 301

“weak link for fire”.<sup>2013</sup> The sketch showed the new window set back from the edge of the building, exposing a gap between the window brackets, as shown below.<sup>2014</sup>

**57.55** Ben Bailey thought that the purpose of Mr Mort’s email and sketches was to provide a solution to the dispute about whether there should be cavity barriers or firestopping<sup>2015</sup> and he noticed that Mr Mort had drawn cavity barriers at the

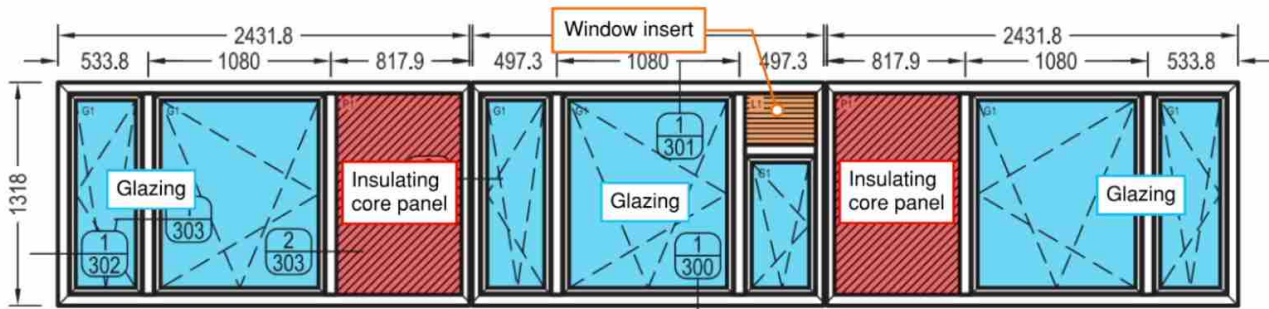
**Figure 58.1 – Typical elevation for three-window configuration**

**58.3** After the fire it was found that both panels contained a core of Styrofoam, held between two sheets of aluminium.<sup>2153</sup> Styrofoam is a form of extruded polystyrene (often referred to as “XPS”) and is combustible.<sup>2154</sup> Although in his Phase 2 experimental work Professor Bisby found that those panels made the lowest contribution to the energy available in the external wall (only about 2–3% of the total energy available per floor),<sup>2155</sup> he also found that they were relatively easy to ignite and, once ignited, had a comparatively high energy heat release rate per unit area.<sup>2156</sup> He concluded that although they were not a primary cause of, or contributor to, the spread of fire across the external walls, they may have played an important part in the

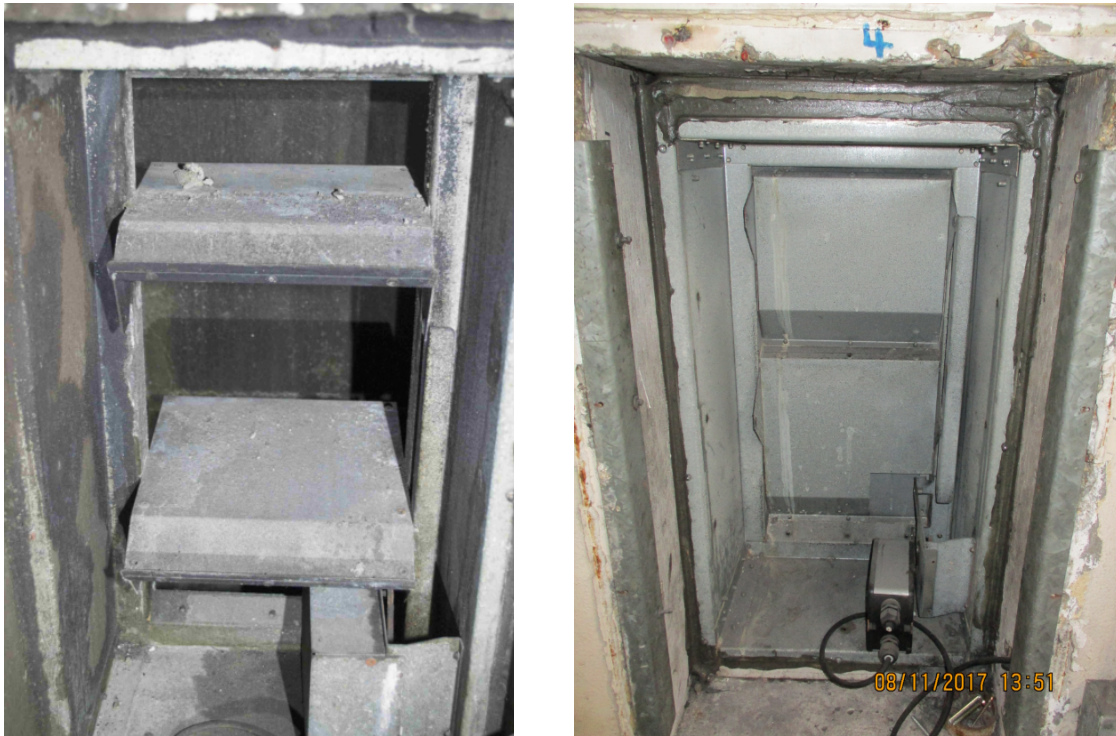
**Figure 60.3 – Examples of dampers in an open and closed position**

**60.49** The Gilberts Series 54 damper is shown in the open and closed positions in the following photographs taken after the fire.<sup>2407</sup>

**60.50** It is opened and closed by an actuator (a small electric motor)<sup>2408</sup> that moves the blades. When smoke is being drawn up the shaft the damper prevents it from entering the lobbies. It therefore plays a vital role in protecting the atmosphere in the lobbies not directly affected by the fire.
