GRENFELL TOWER INQUIRY: PHASE 2 REPORT

REPORT of the PUBLIC INQUIRY into the
FIRE at GRENFELL TOWER
on 14 JUNE 2017

Volume 5
Part 7 - Replacement of the gas riser
Part 8 - The London Fire Brigade

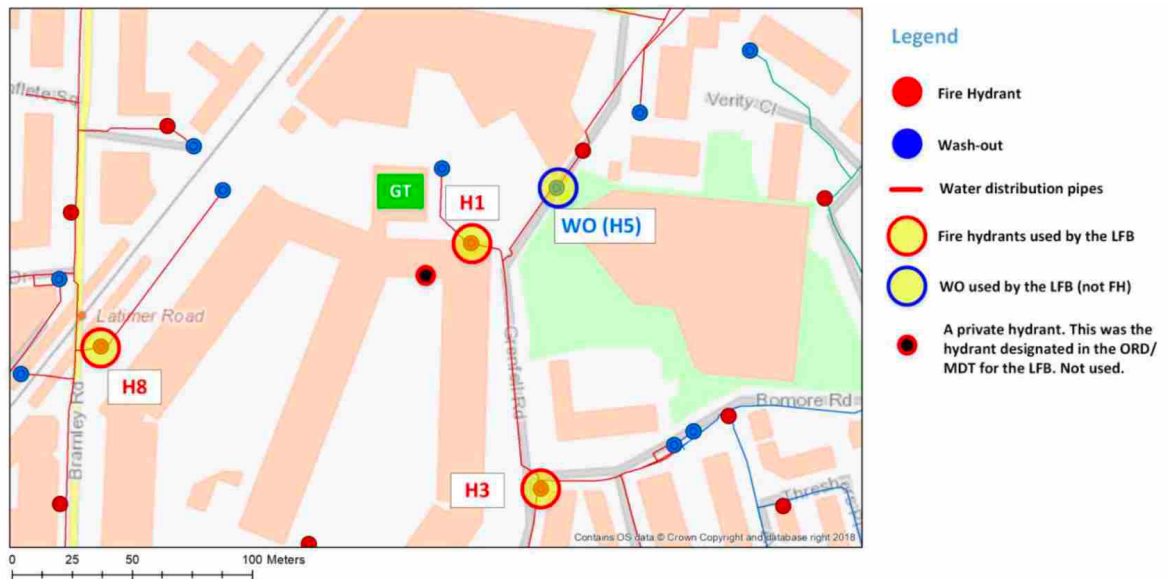
Figure 81.1: The four hydrants, highlighted in yellow, used to supply water at Grenfell Tower on 14 June 2017.
