GRENFELL TOWER INQUIRY: PHASE 2 REPORT

REPORT of the PUBLIC INQUIRY into the
FIRE at GRENFELL TOWER
on 14 JUNE 2017

Volume 5

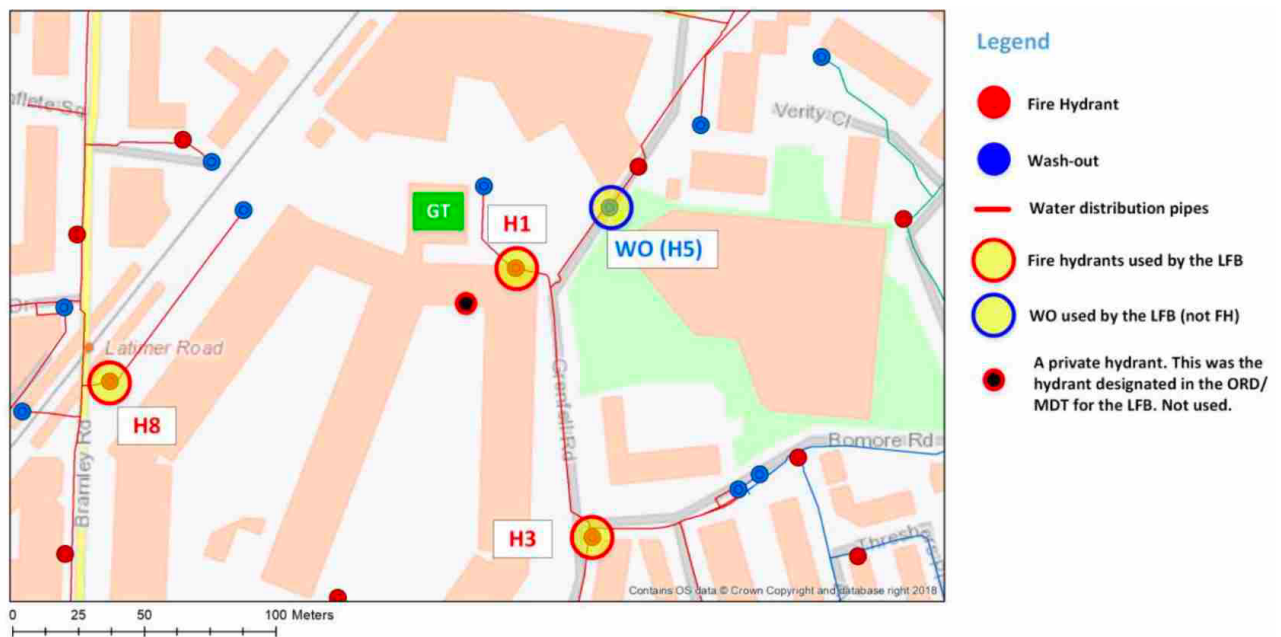
Figure 81.1: The four hydrants, highlighted in yellow, used to supply water at Grenfell Tower on 14 June 2017.
