## **GRENFELL TOWER INQUIRY: PHASE 2 REPORT**

REPORT of the PUBLIC INQUIRY into the  
FIRE at GRENFELL TOWER  
on 14 JUNE 2017

Volume 4

Part 6 – The refurbishment of Grenfell Tower

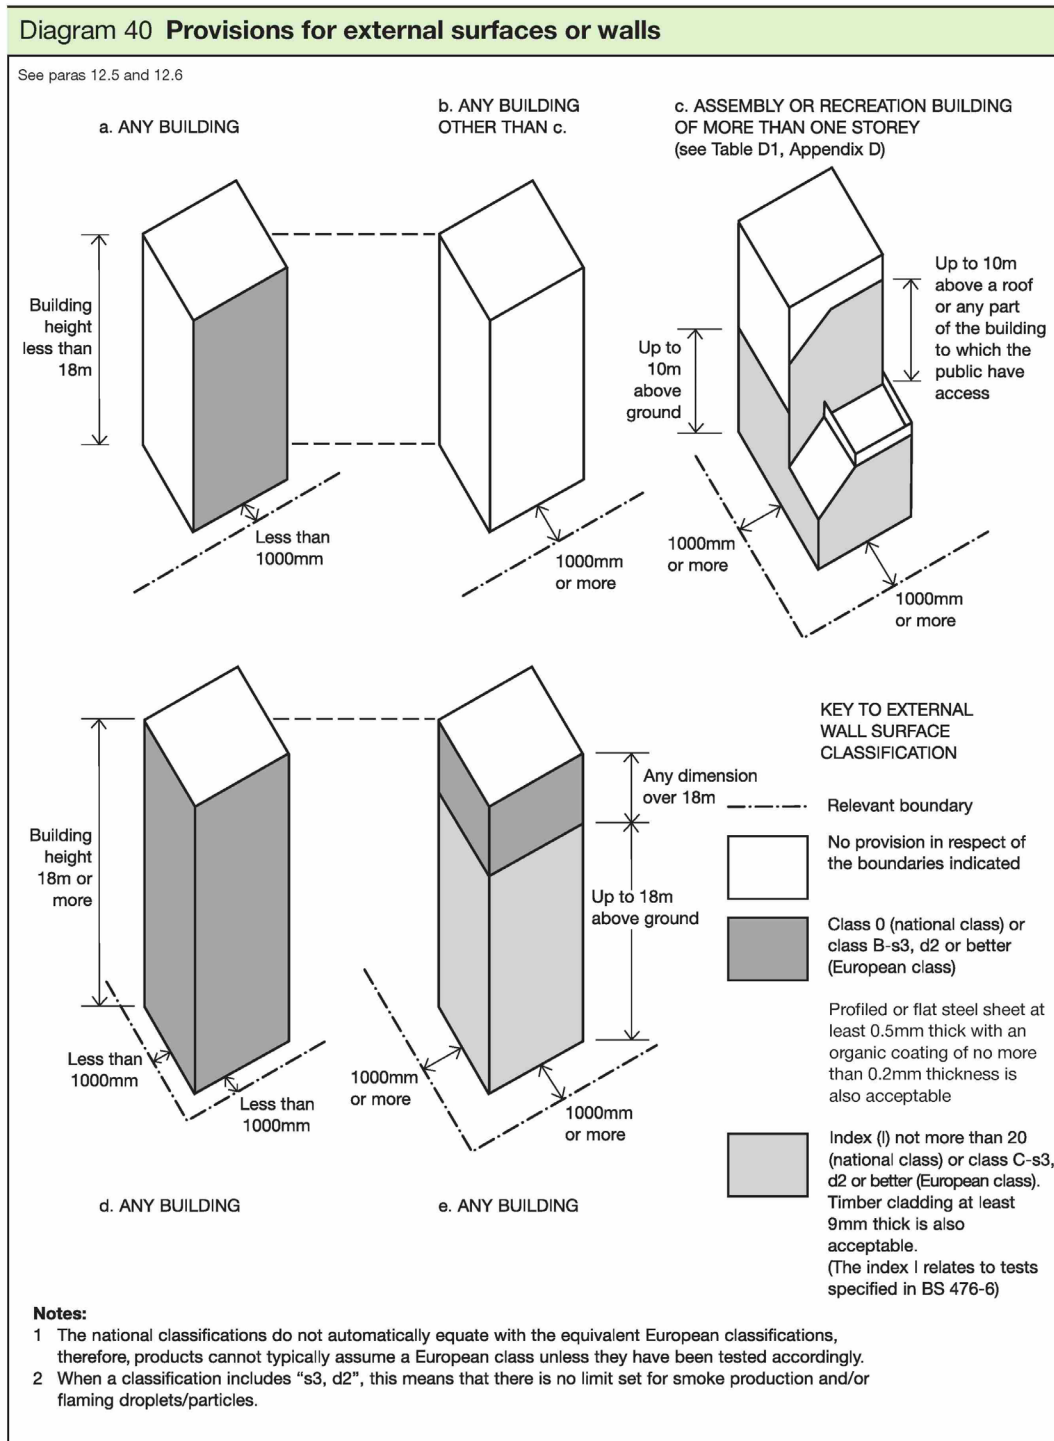
Figure 48.1 – Diagram 40

48.26 The heading of Diagram 40 (in particular the use of the words “or walls”) might suggest that a distinction is being drawn between “external surfaces” and “walls” but the label in the key to

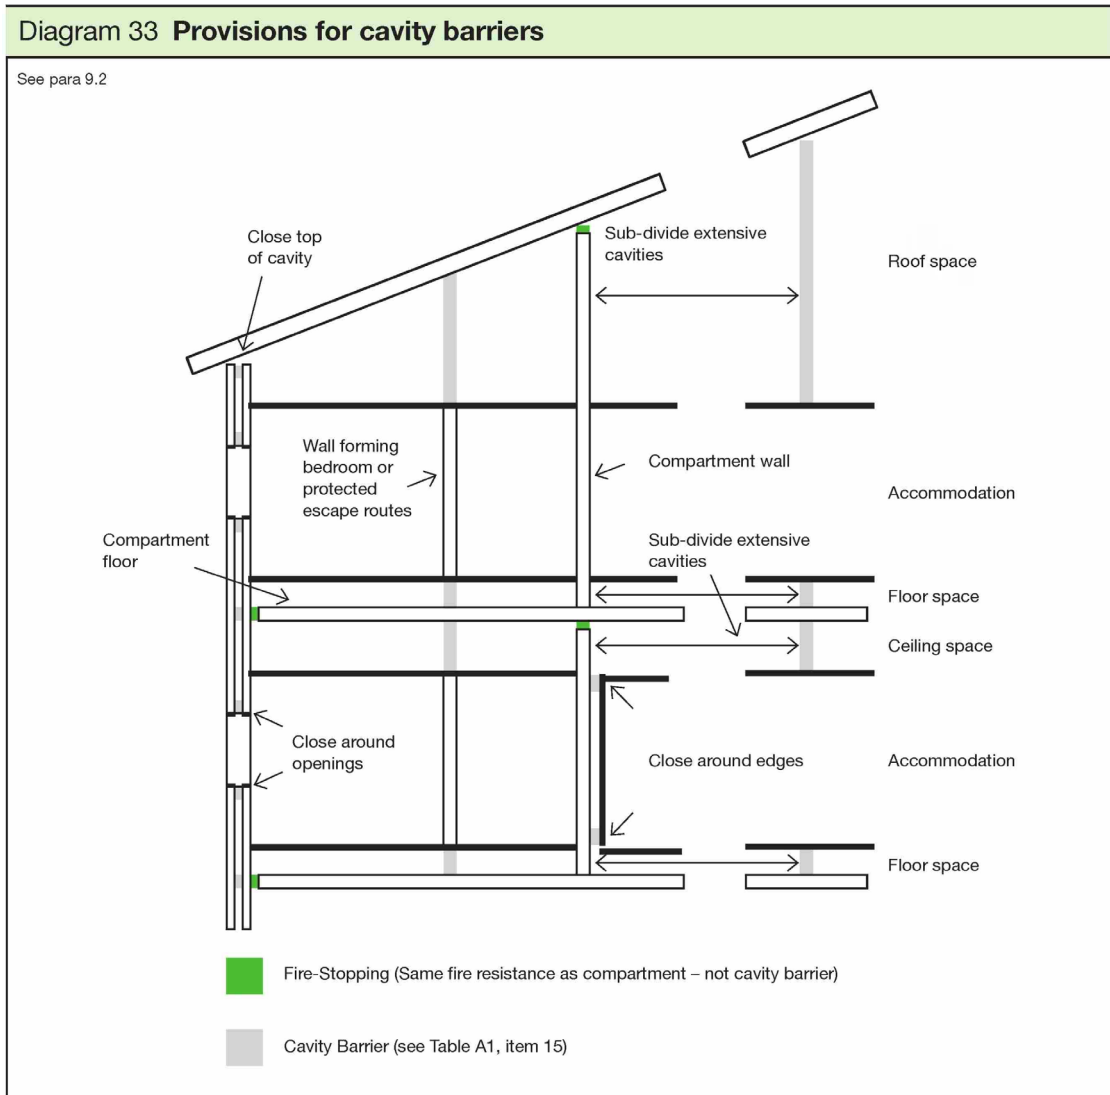
Figure 48.2 – Diagram 33

**48.34** Paragraph 9.13 gives guidance on the construction and fitting of cavity barriers and states that they should provide at least 30 minutes' fire resistance.<sup>26</sup> Cavity barriers should be distinguished from fire stopping, which is a seal provided to close an imperfection of fit or design tolerance between elements or components, to restrict the passage of fire and smoke.<sup>27</sup>

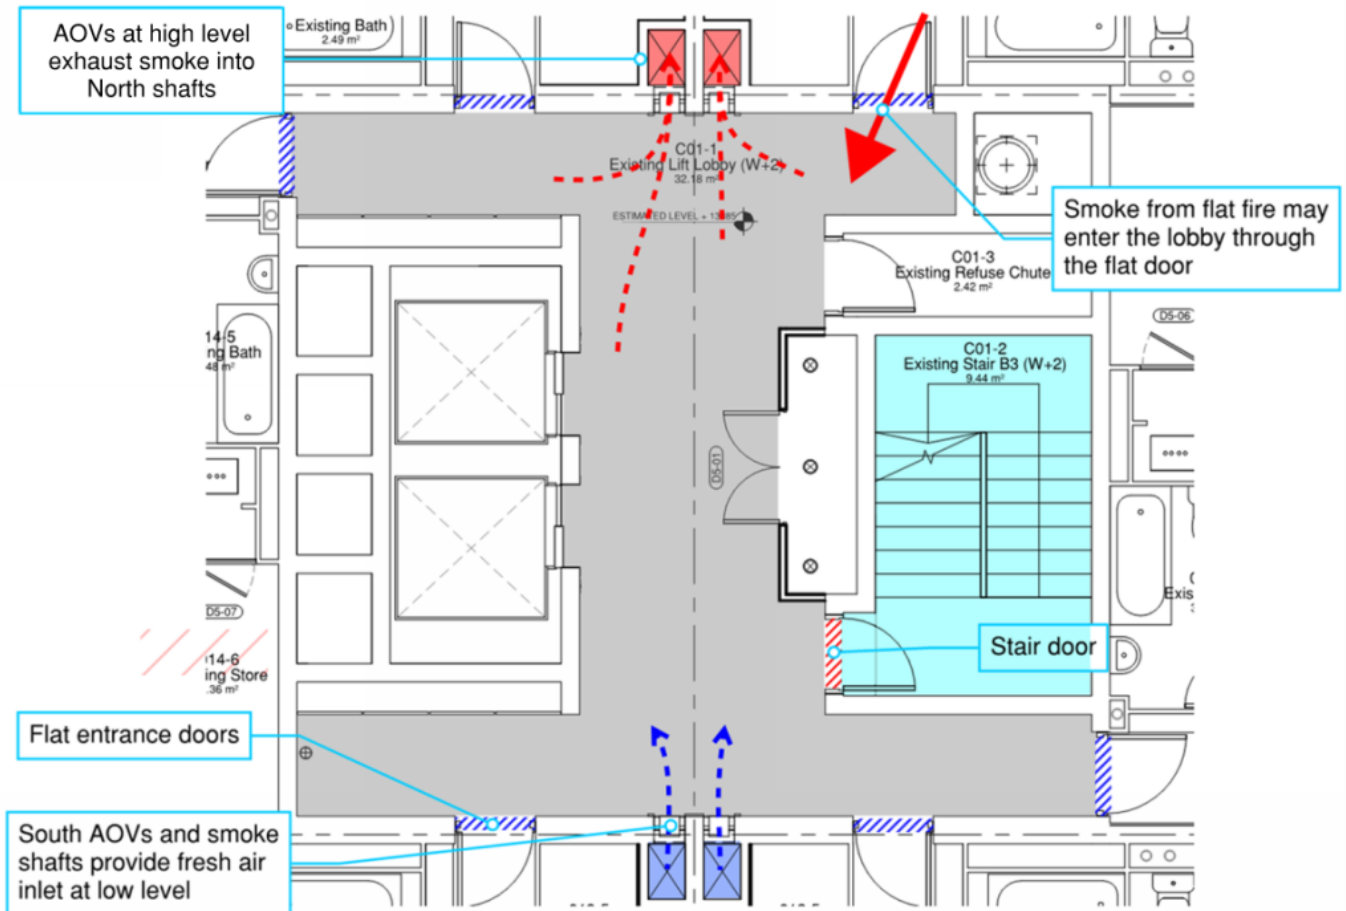
**Figure 60.1 – Operation of the original smoke ventilation system on the fire floor**

**60.6** Accordingly, the system operated by ventilating the lobby area with the intention of protecting the escape route through the lobby.

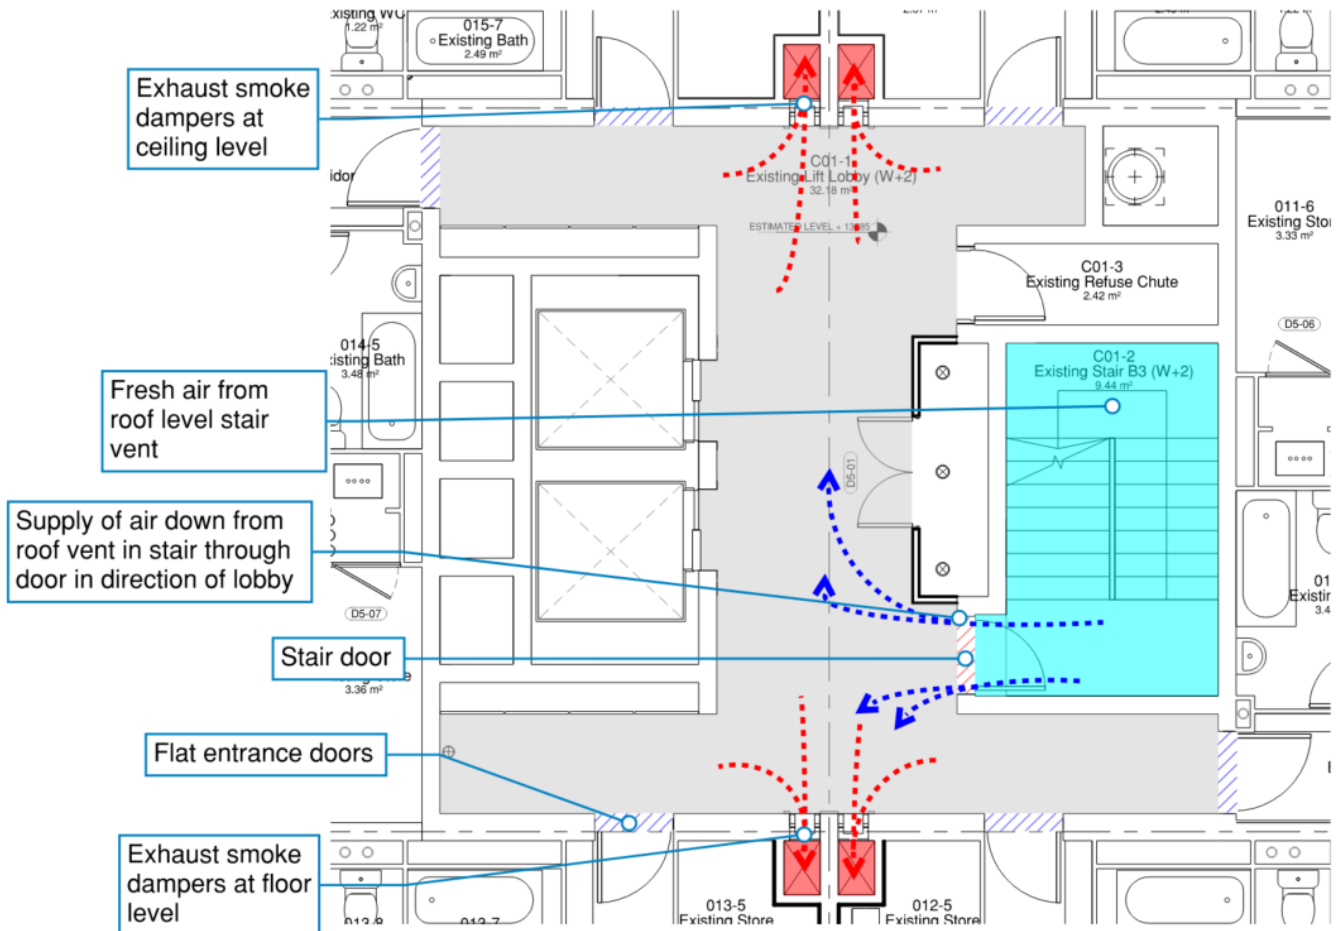
**Figure 60.2 - Design intent of the smoke extract system in Grenfell Tower for Level 2 to Level 23**

**60.34** Mr Mahoney said that the advantage of the design was that by using four shafts rather than two to extract smoke from the lobbies, the velocity required to achieve the required rate of extraction was reduced. In his opinion, seeking to achieve a higher flow rate using only two shafts for extraction and two for the entry of air was not viable, because the higher air speed required through each shaft would have disrupted the flow.
